Description of Gasket Failure in a 7 Cell PEMFC Stack

Attila Husar, Maria Serra, Cristian Kunusch*

Institut de Robòtica i Informàtica Industrial, Parc Tecnològic de Barcelona. Edifici U
C. Llorens i Artigas, 4-6, 2a planta, 08028 Barcelona, España

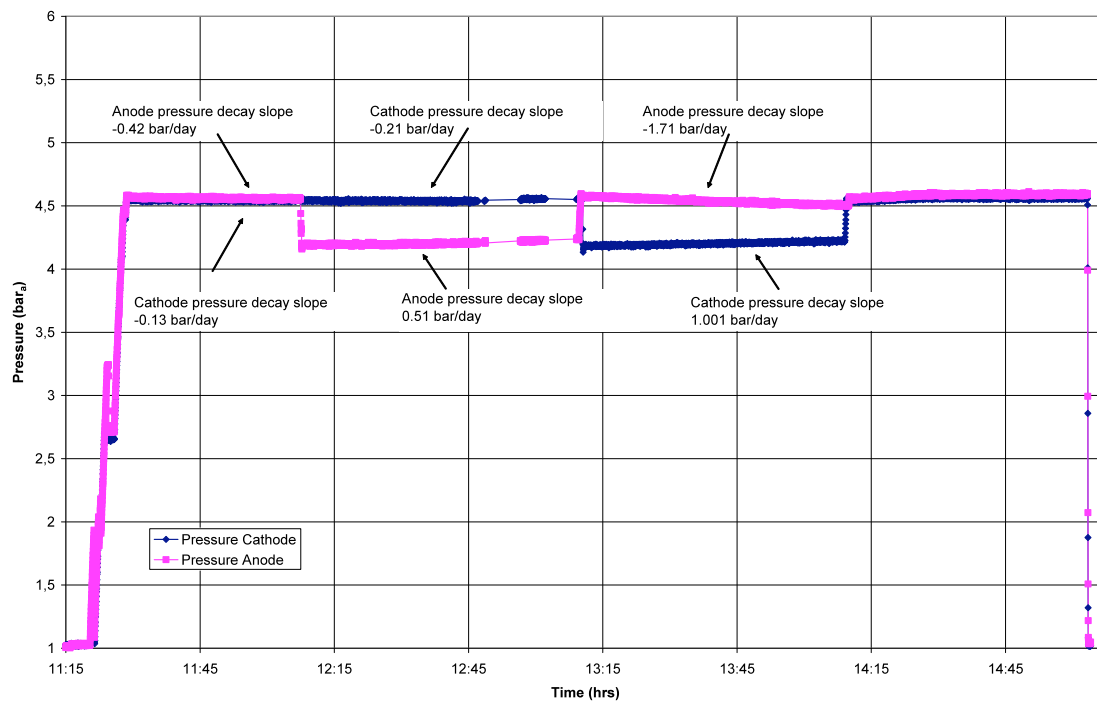
anode pressure was increased back up to 4.5 bar_a and the cathode pressure was reduced to 4.2 bar_a. The slope of each section of the test is indicated on the graph. Figure 3 shows an increasing slope of the lower pressure side of the membrane indicating that gas from the higher pressure side of the membrane is crossing over to the low pressure side. The exact rate is unknown because a true crossover leak check was not done on this stack due to the lack of equipment. No combustion occurred during the leak test because nitrogen was being used on the anode.

Fig. 3. Pressure decay leak check of stack at ambient temperature with air on the cathode and nitrogen on the anode

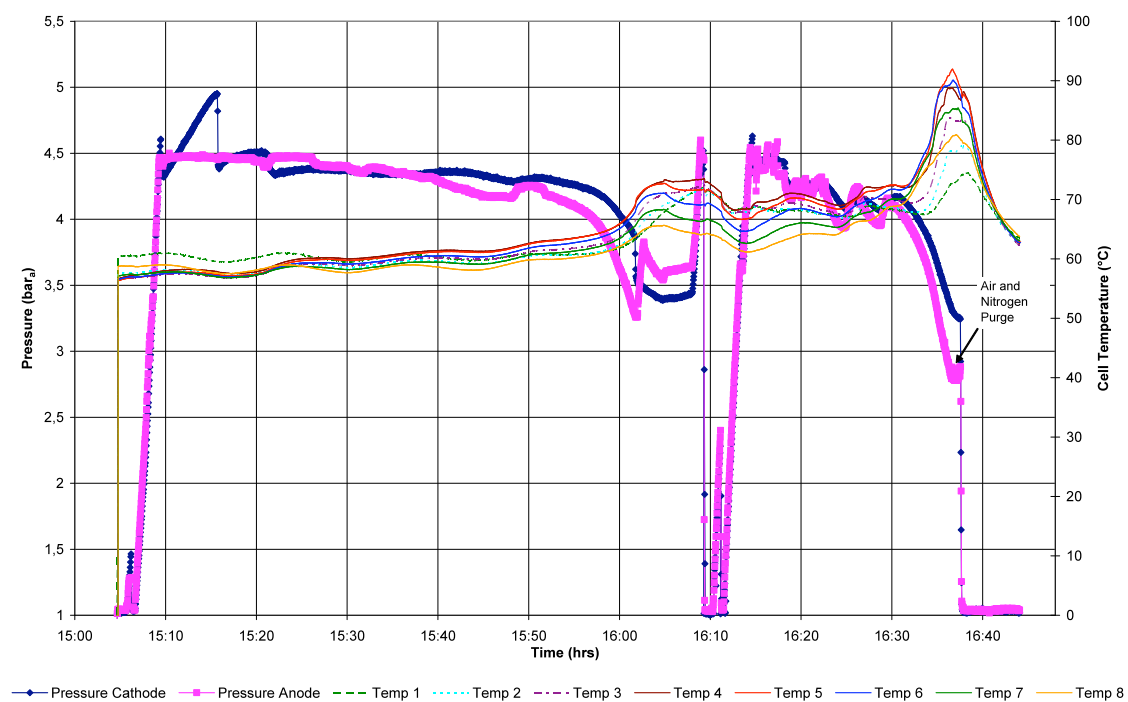
The stack temperature was the indicator that led to the final shutdown of the stack. The stack was being operated with oxygen and hydrogen and no humidification. The stack temperature reached 90°C without current or resistance heaters enabled. The hot point in the stack was in the middle cells, which read a temperature of 91°C. The pressure in the stack could not be maintained. Both of these symptoms indicated a crossover leak and combustion. So the stack was purged with nitrogen, and declared inoperable.

The data for these final hours with respect to pressure and temperature is shown in figure 4, which shows spikes in temperature as the pressures decayed. The cell temperature measurements were taken at eight different points throughout the stack located in the bipolar plates in between each cell. For simplicity purposes they were called measurements 1 through 8, where measurement 1 is located between the end plate and cell #1, where cell #1 is the first cell the gasses encounter when they enter the stack.

Fig. 4. Pressure of the reactant gasses vs. cell temperature during the last hours of operation. **H₂/O₂, no humidification??**

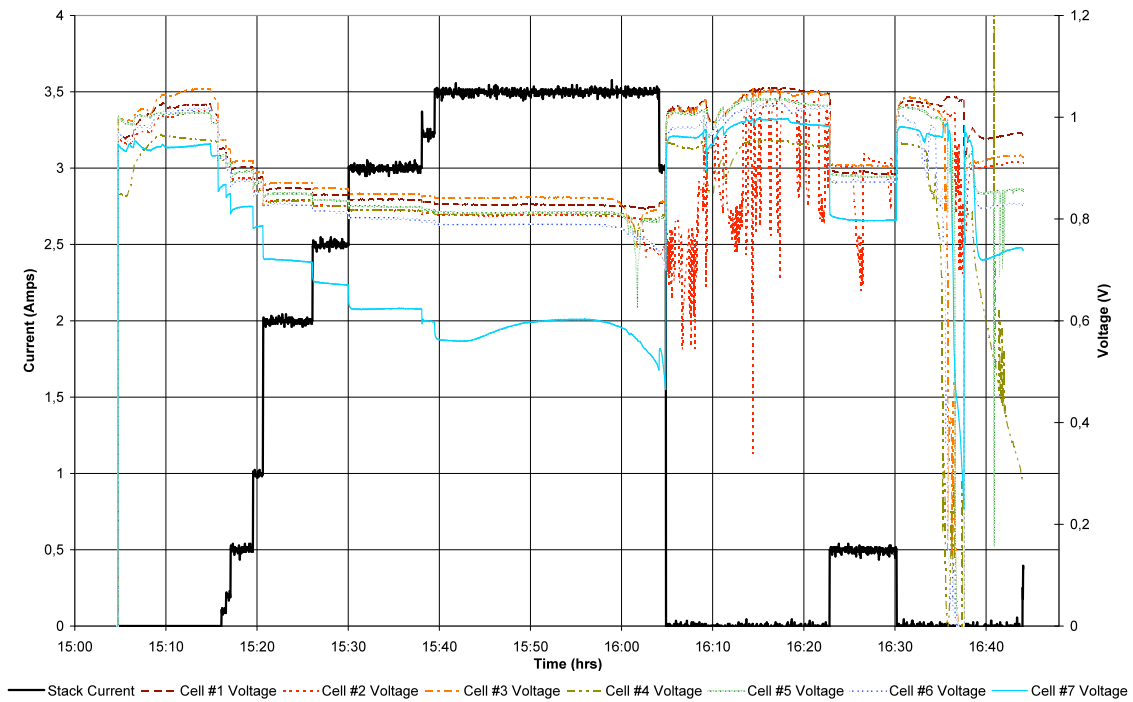
Figure 5 depicts the stack current versus the individual cell voltages, which indicate that after the current was reduced to 0 at around 16:05, the open circuit voltages became very unstable especially that of cell #2.

Fig. 5. Stack current vs. individual cell voltage during the last hours of operation, H₂/O₂, no humidification and a gas pressure??

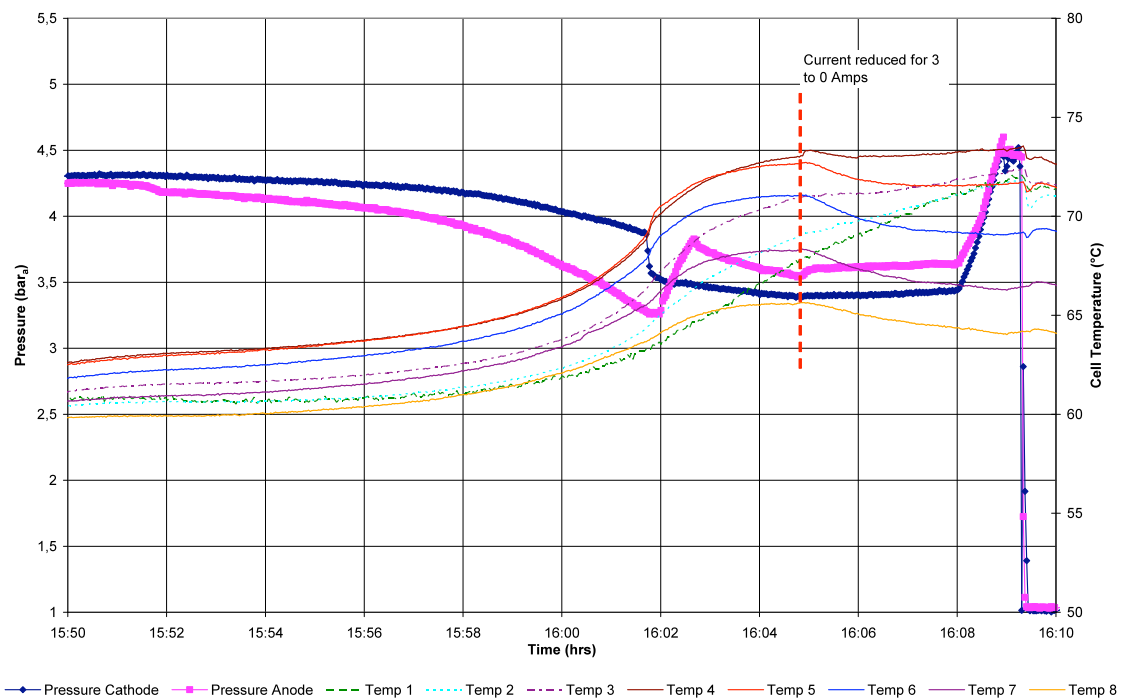
In figure 6 the time between 15:50 and 16:10 is examined with respect to pressure and cell temperature. When the load was removed from the stack at 16:05 the temperature measurements 4 to 8 started to decline as was expected. However, the temperature measurements 1 to 3 continued to increase. This temperature rise showed signs of a breach possibly in cell #1 and/or #2.

Fig. 6. Zoom of fig 4 between 15:50 and 16:10. Increase in temperature in cells #1 and #2 with no electric load or external heaters on the stack and an anode reactant pressure higher than the cathode pressure when the load was removed

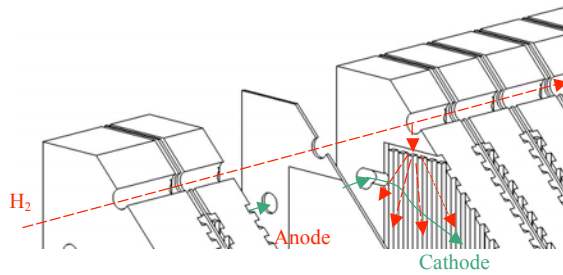
Figure 7 explains how a breach in one cell affects the flow of the reactant gases when the pressure of the anode is higher than the cathode. Hydrogen enters directly into the breached cell and combusts in the catalyst layer, therefore increasing the temperature for just that one cell.

Fig. 7. Flow of the reactant gases when there is a breach in the seal at the anode inlet port that goes into the cathode flow field. Anode pressure is higher than the cathode's

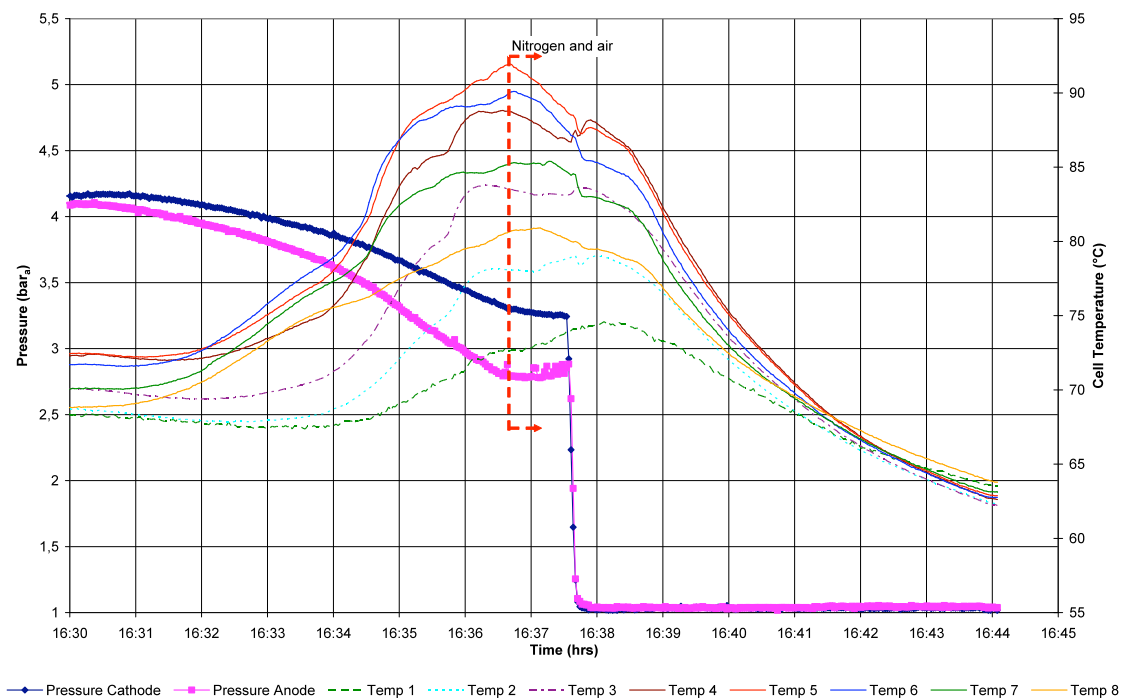
In figure 8 the time between 16:30 and 16:45 is examined with respect to anode and cathode pressure and temperature. Initially both pressures were equalized, however the anode pressure started to decline more rapidly than the cathode because hydrogen was being consumed at twice the rate of the oxygen due to combustion which, in turn, caused more oxygen to be forced into the anode inlet port thus, increasing the rate of combustion in the cells located after the breach. Once the nitrogen purge was initiated on the anode and air purge on the cathode the pressures began to stable out and the cell temperatures decreased. Shortly after, the pressure was reduced to atmospheric and the stack was declared inoperable.

Fig. 8. Zoom of fig. 4 between 16:30 and 16:45. Cathode pressure is higher than the anode's and the hot spots in the stack are from cell #3 to #6 indicating that the oxygen was entering into the hydrogen stream through the inlet port

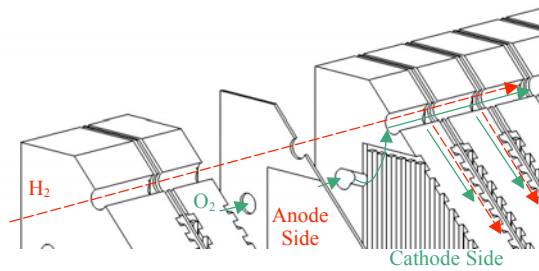
Since the breach is reversible it should permit the oxygen to enter into the anode inlet port if the cathode pressure was higher than that of the anode as shown in figure 9. Therefore, the oxygen breach should only affect the subsequent cells.

Fig. 9. Flow of the reactant gases when there is a breach in the seal at the anode inlet port. Oxygen is entering into the anode inlet port. Cathode pressure is higher than the anode's

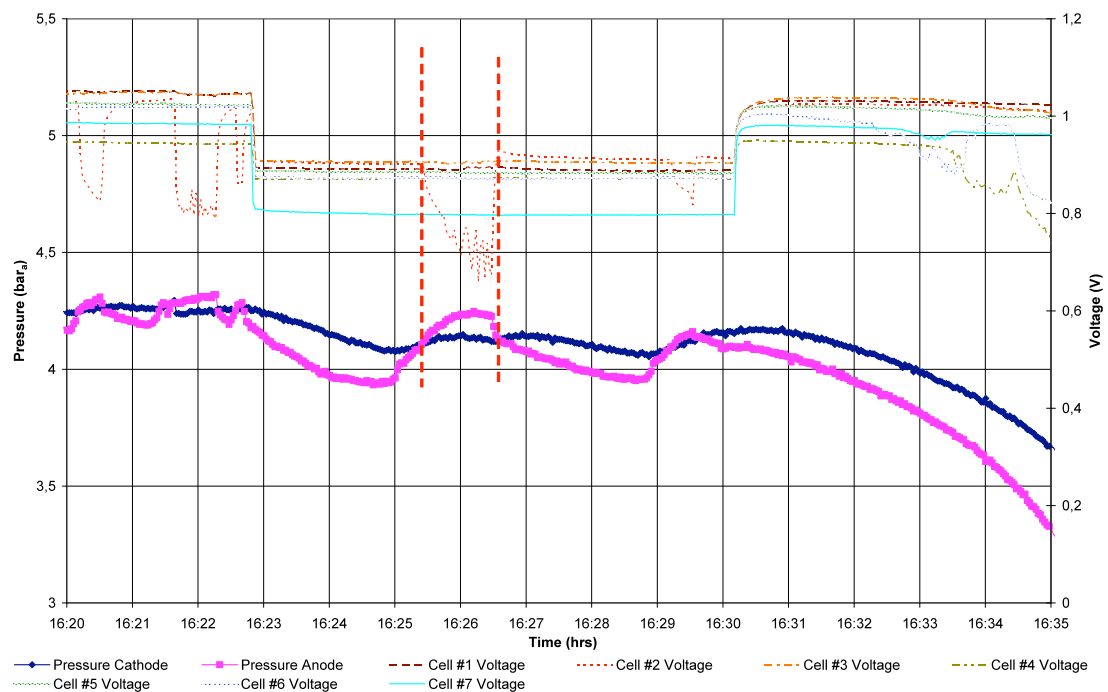
Cell #2 in Figure 10 showed a unique behavior when the anode pressure was higher than the cathode pressure. The cell lost about 20 mV and became unstable. Then, when the anode pressure was decreased to be lower than the cathode's the cell stabilized. This indicates that there was hydrogen crossover in cell #2.

Fig. 10. Temporary instability of cell #2 when the anode pressure is higher than the cathode's. Hydrogen enters directly into the cathode flow field of the cell

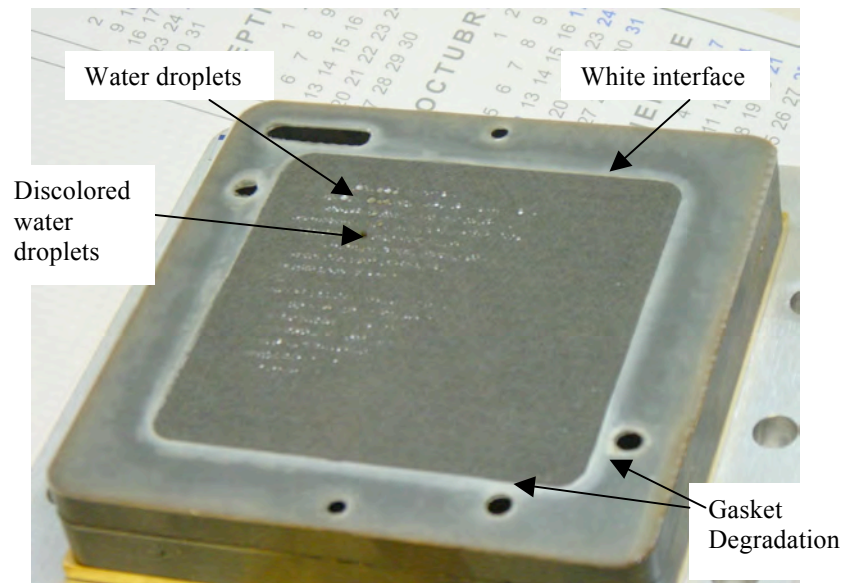
Upon opening the stack it was clear that it was cell #2's cathode side gasket that had failed. Figure 11 shows the cathode gasket and GDL for cell #2 while still attached to the bipolar plate. The interface between the gasket and the GDL is an off white color indicating degradation.

Interestingly, this was the only cell that had water droplets on the gas diffusion layer and a few of the droplets were brown in color which is a sign of contamination possibly from combustion on the cathode side.

Figure 11. Cathode GDL and gasket of cell #2 before it was removed from the bi-polar plate

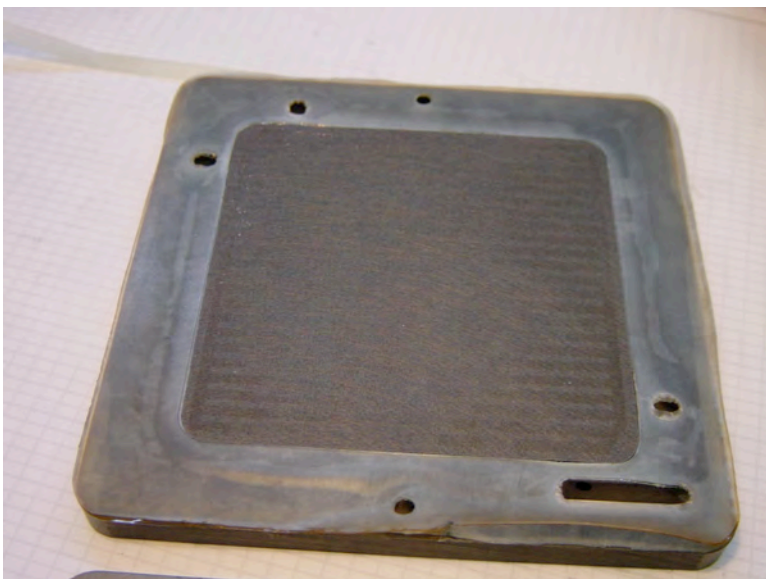
Figure 12 illustrates what a good cell with no degradation of the gasket should look like.

Figure 12. Cell # 5 gasket and diffusion layer which showed no degradation

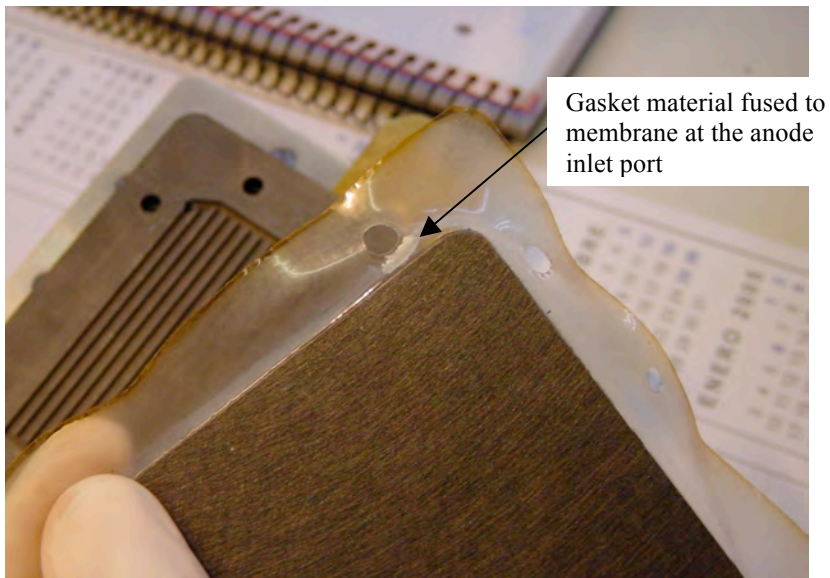
Finally, when the gasket was totally detached from the membrane it was discovered that a piece of the gasket material was fused to the membrane at the anode inlet port as seen in Figure 14. This could be explained by the high

temperature reached due to combustion that caused the gasket material to disintegrate and fuse to the membrane.

Figure 14. Gasket material left on the membrane at the anode inlet port and on the cathode side of the membrane

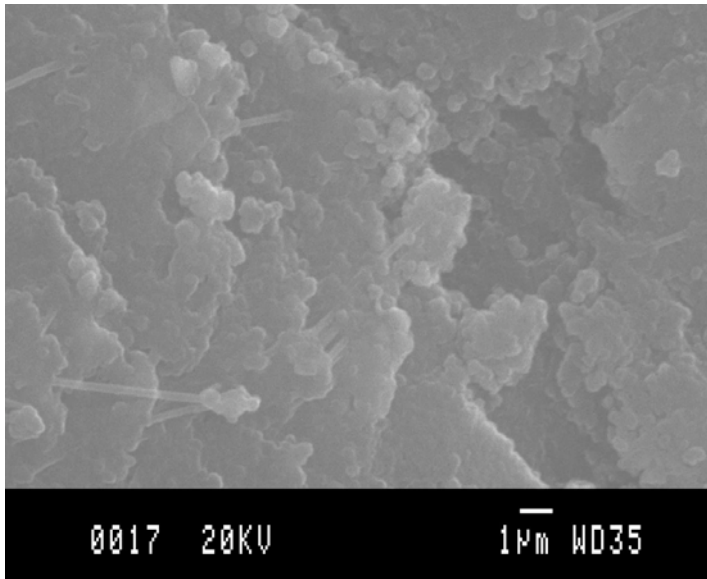
Figures 15 & 16 show images of the silicon gasket material taken with the scanning electron microscope. In figure 15 the silicon gasket material was exposed to combustion from cell #2, and figure 16 shows what the same material looks like under regular conditions.

Fig. 15. Silicon gasket material that was exposed to the combustion from cell #2

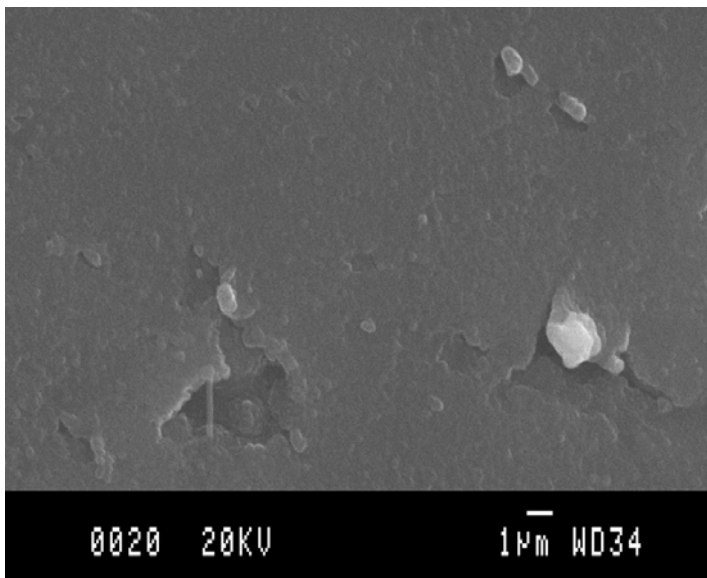
Fig. 16. Silicon gasket material that was not exposed to the combustion from cell #4
